New York State Department of Transportation

PIA Safety Flag NB23CTW001

BIN: 1065318

Feature Carried: 278I278IX2M23027

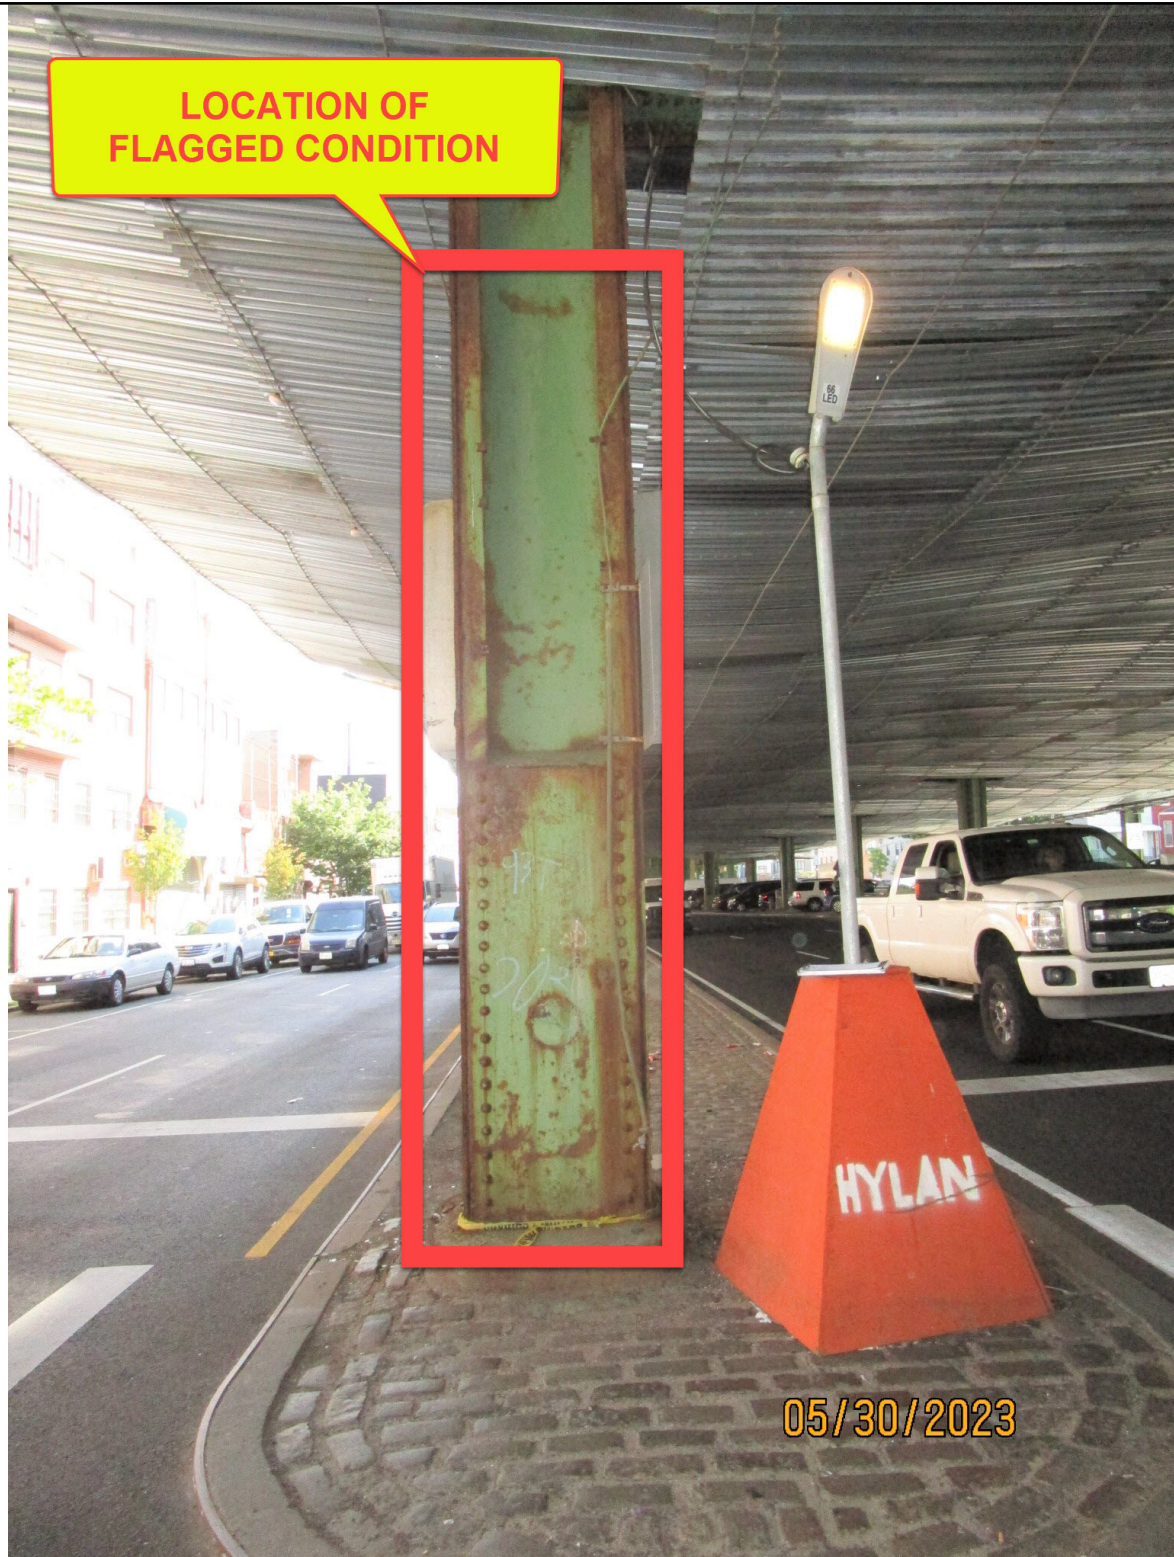
Photo Number: 2

Attachment Description: General View of Column C1 at Pier 83. Looking End. (For specific Flag Location at Column C1 base, see Photo Nos. 3 and 4 that follow).

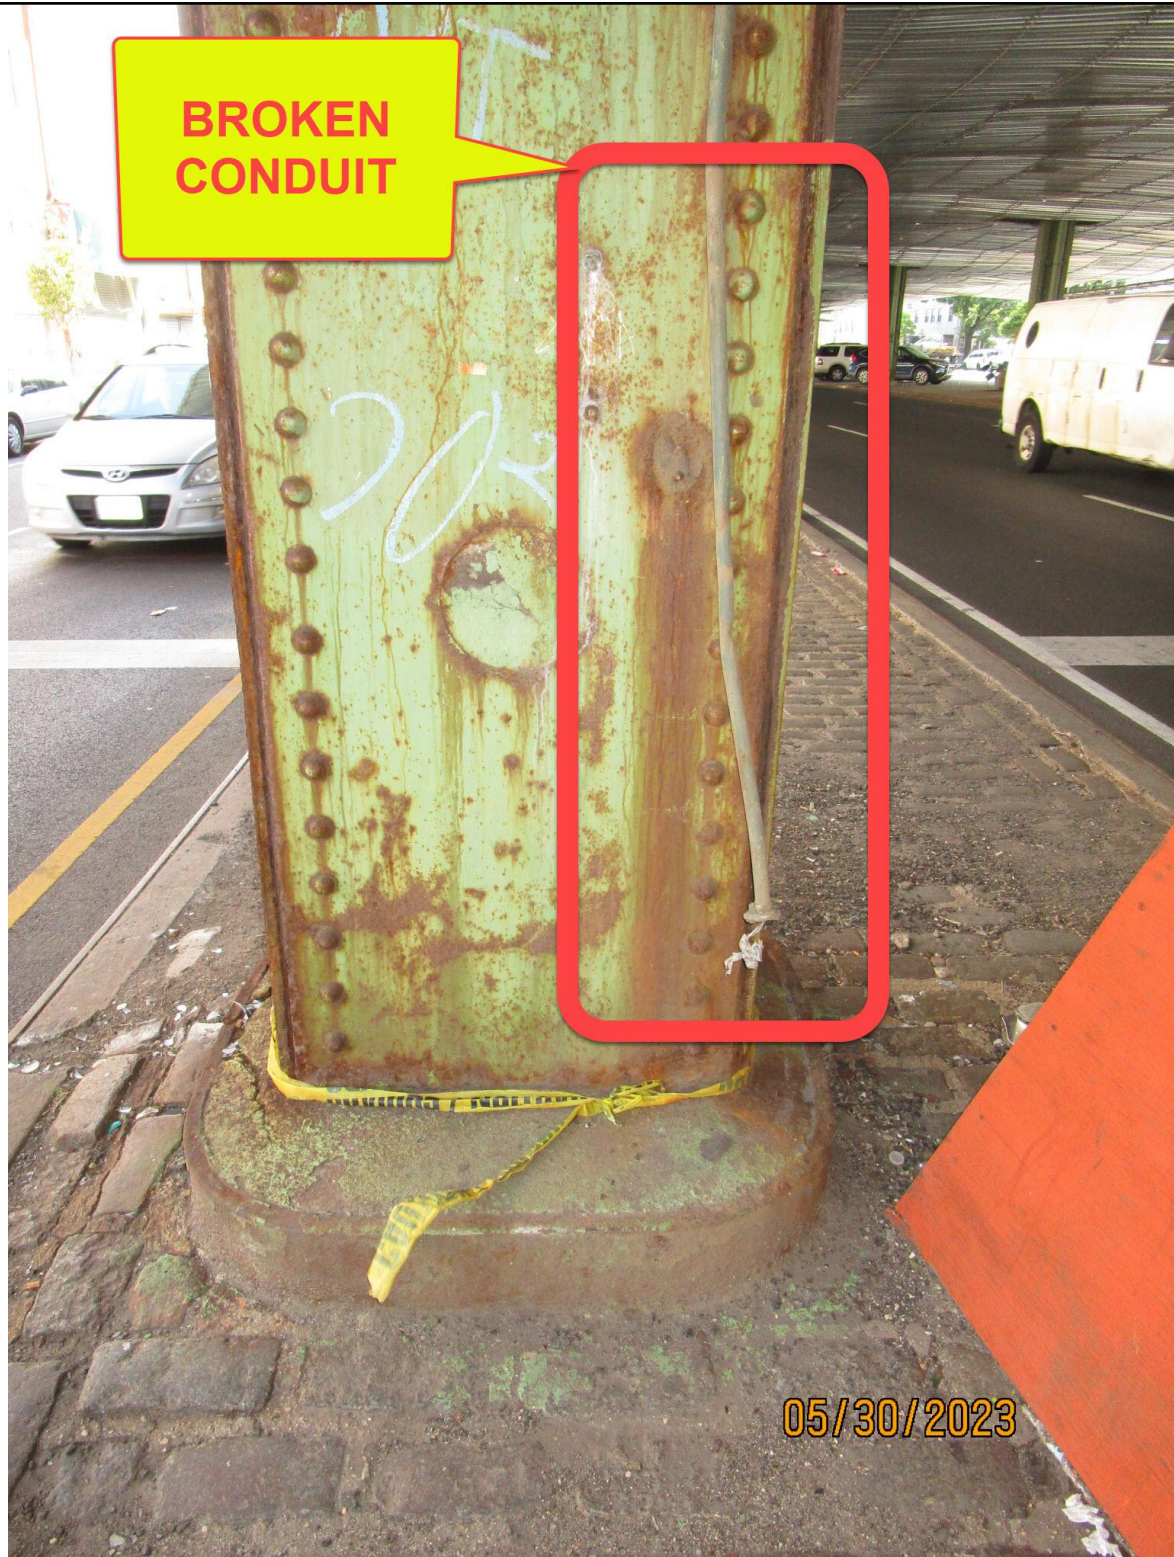
Photo Number: 3

The electrical conduit attached at the begin face of Column C1 is broken (no junction box). There are exposed live wires at the conduit end near the base of the column. The subject location is at the intersection of 55th Street and westbound 3rd Avenue service road, adjacent to a pedestrian walk and is accessible by the public.

Attachment Description: General view of broken electrical conduit at column base with exposed live wires. Looking End.

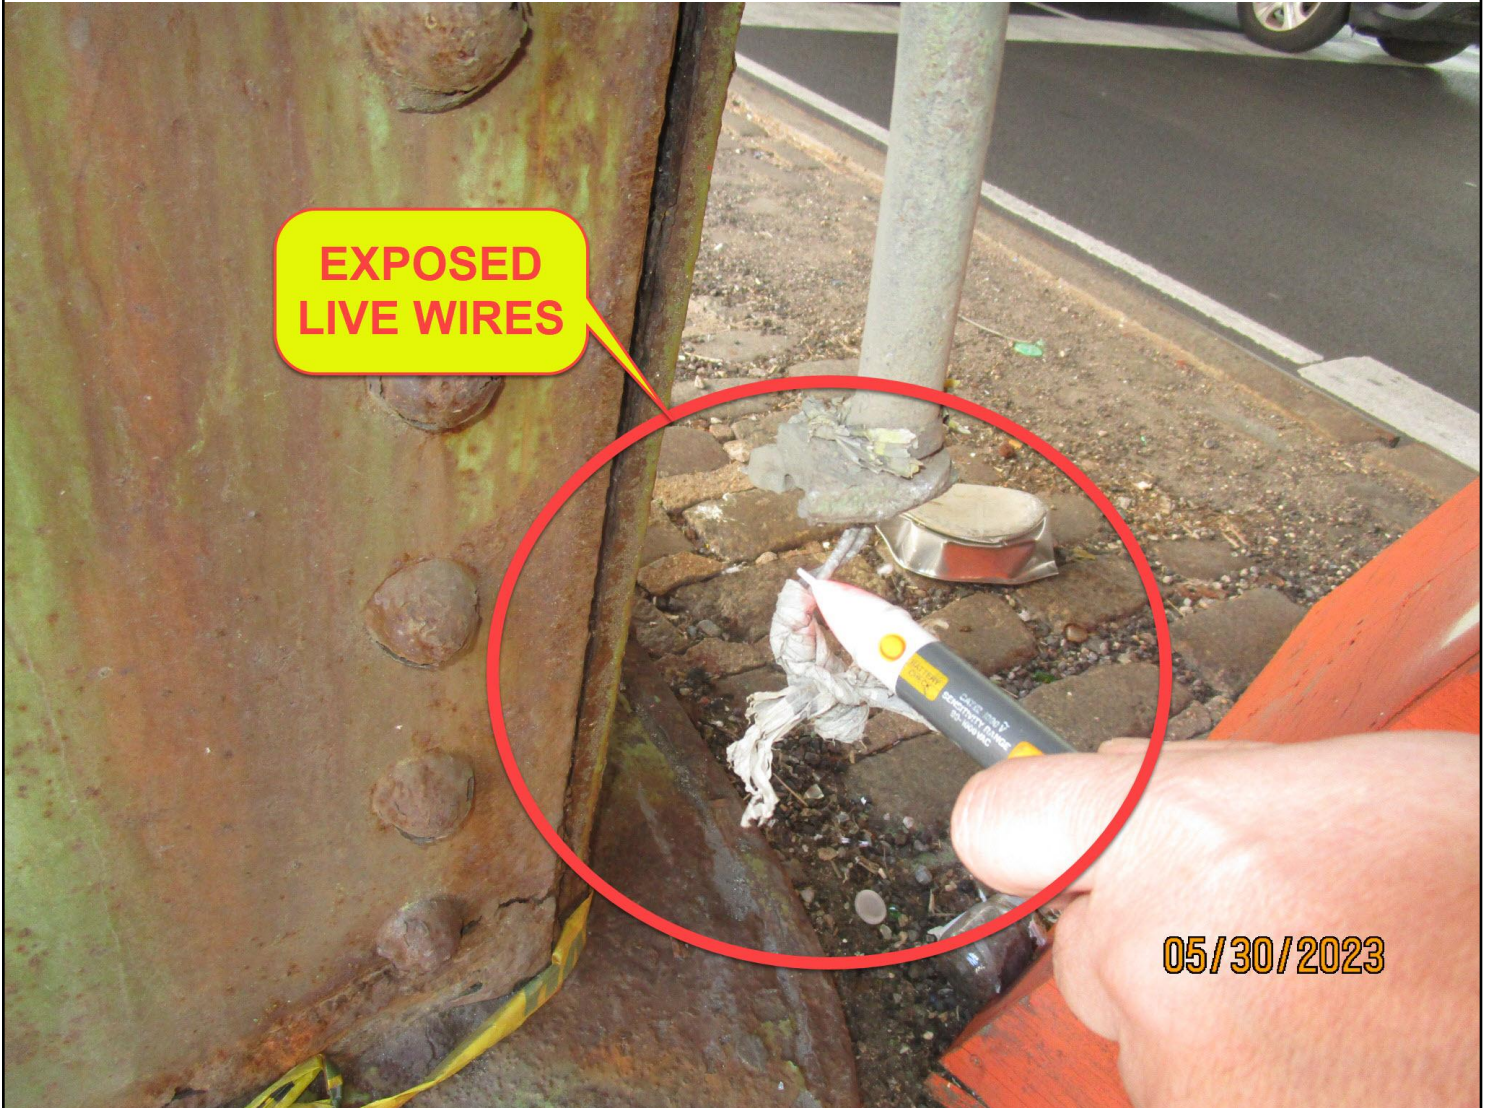
Photo Number: 4

Attachment Description: Close up view of broken electrical conduit at column base with exposed live wires.
Looking End.

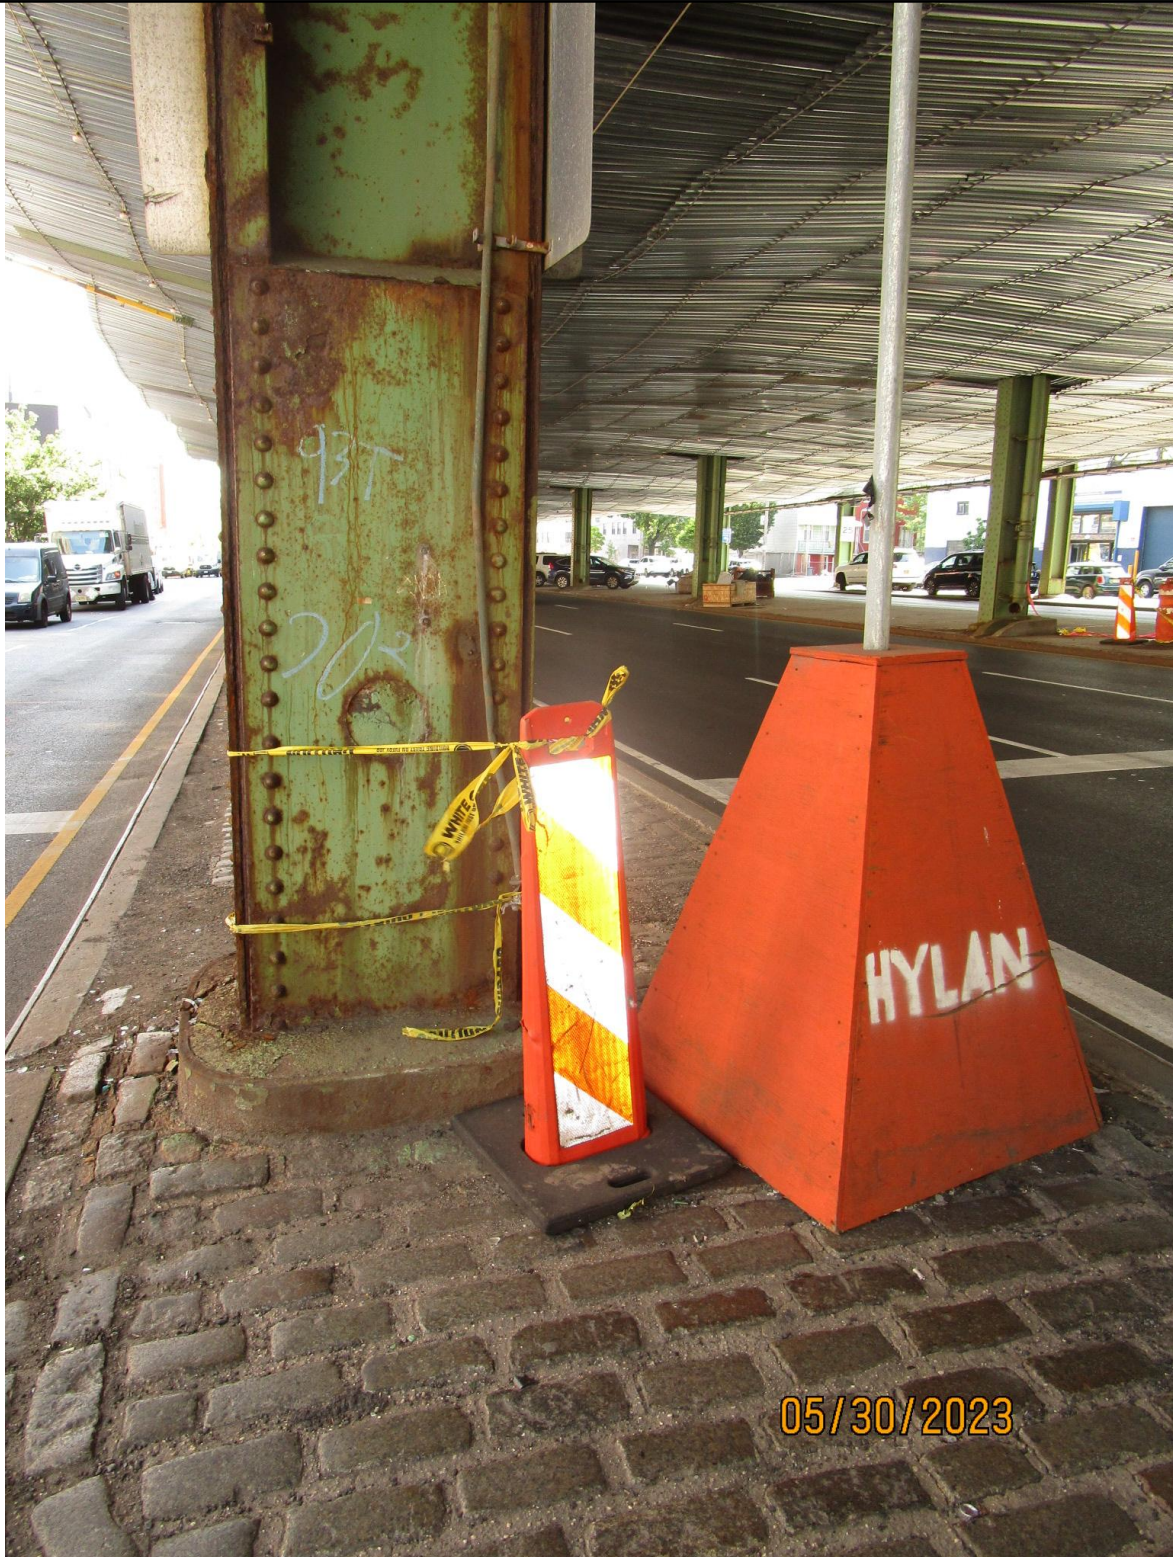
Photo Number: 5

Attachment Description: Flagged location temporarily secured by the inspection team. Looking End

The inspection team temporarily secured the location using caution tape. However, this condition warrants a PIA Safety Flag.
